HOME
report

SINGLE SURVEY
ENERGY REPORT
PROPERTY QUESTIONNAIRE
VALUATION REPORT

Single Survey

Property Address	181 Mill Road Cambuslang Glasgow G72 7YS
Customer	Mr M Wells
Date of Inspection	29/10/2024
Prepared by	R Fitzpatrick Harvey Donaldson & Gibson Chartered Surveyors

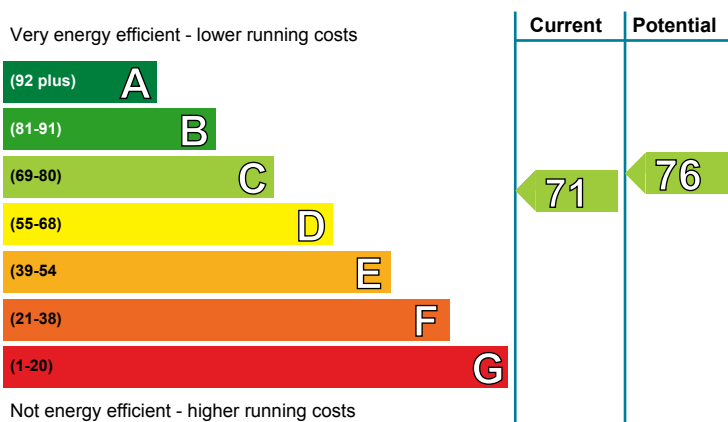
Energy Efficiency Rating

This graph shows the current efficiency of your home, taking into account both energy efficiency and fuel costs. The higher this rating, the lower your fuel bills are likely to be.

Your current rating is **band C (71)**. The average rating for EPCs in Scotland is **band D (61)**.

The potential rating shows the effect of undertaking all of the improvement measures listed within your recommendations report.
